Protecting Aluminum Appendages

How to guard against galvanic corrosion between bonded components of dissimilar metals on the same hull.

Text by David Rifkin
Photographs by Dwight Escalera

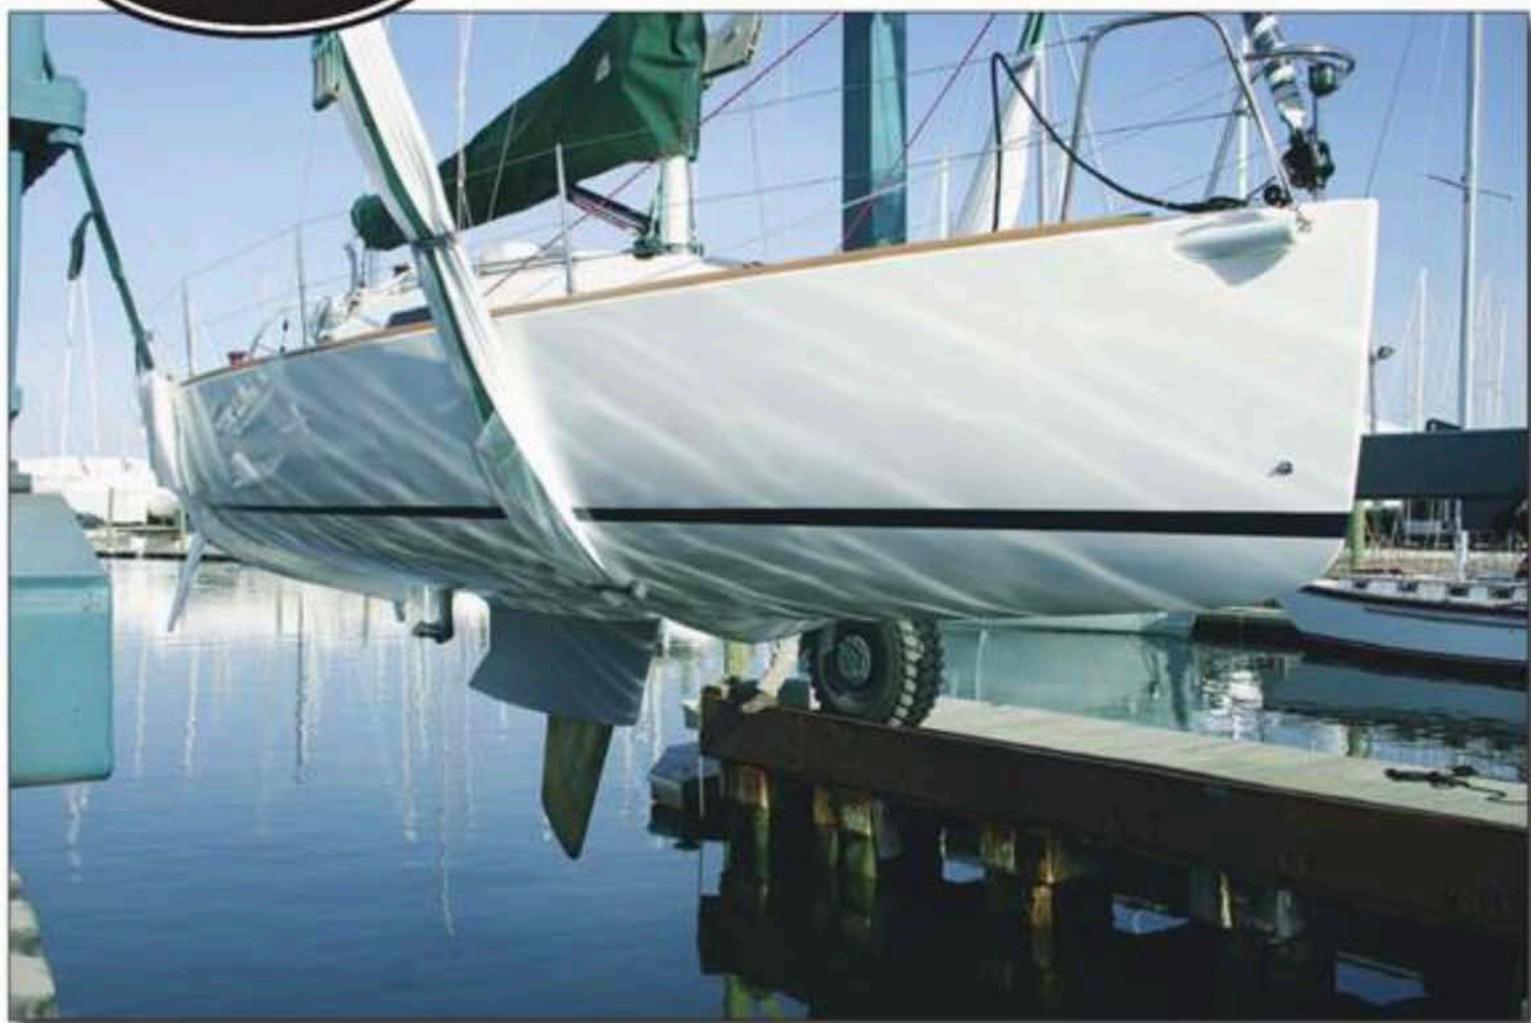
Above—A J/95 (31.2') in slings. Note the bronze centerboard and aluminum sail drive. Installing a special isolator can break the low-voltage "galvanic" circuit between the large cathodic centerboard and the small anodic sail drive.

In actuality, the application that prompted further development of the concept was a sailboat fitted with a bronze centerboard (think: large cathode) and an aluminum sail drive (think: relatively tiny sacrificial anode). Connecting these components together in a bonding system raises galvanic corrosion concerns, because bronze and aluminum are, after all, dissimilar metals making electrical contact in the same saltwater electrolyte.

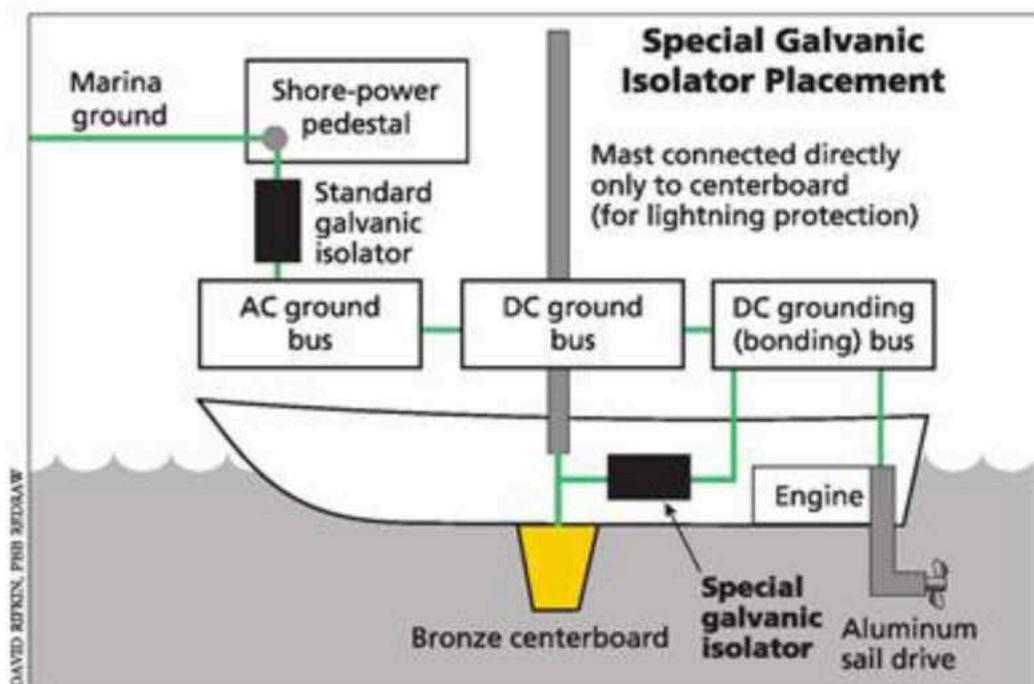
A schematic showing how a special galvanic isolator might be inserted into a boat's grounding system. It's important that the DC ground bus not be connected directly to the mast, and that the centerboard and sail drive be kept electrically isolated—by the galvanic isolator.

This "special" galvanic isolator should be inserted electrically between the bonded components to isolate one from another. In the sailboat it would be installed in series with the bonding conductor, connecting the centerboard to the sail-drive housing (*see illustration on the previous page*).

Take care to ensure there are no other bonding conductors in parallel with the new isolator, since those would bypass the isolator and render it useless. To test for this possible failure, break the bonding system where you want to install the galvanic isolator. Then, if the boat is *out of the water*, measure for continuity between the two electrical connection points for the isolator. The meter should read "OL" (open circuit). If there *is* continuity, then the bonding

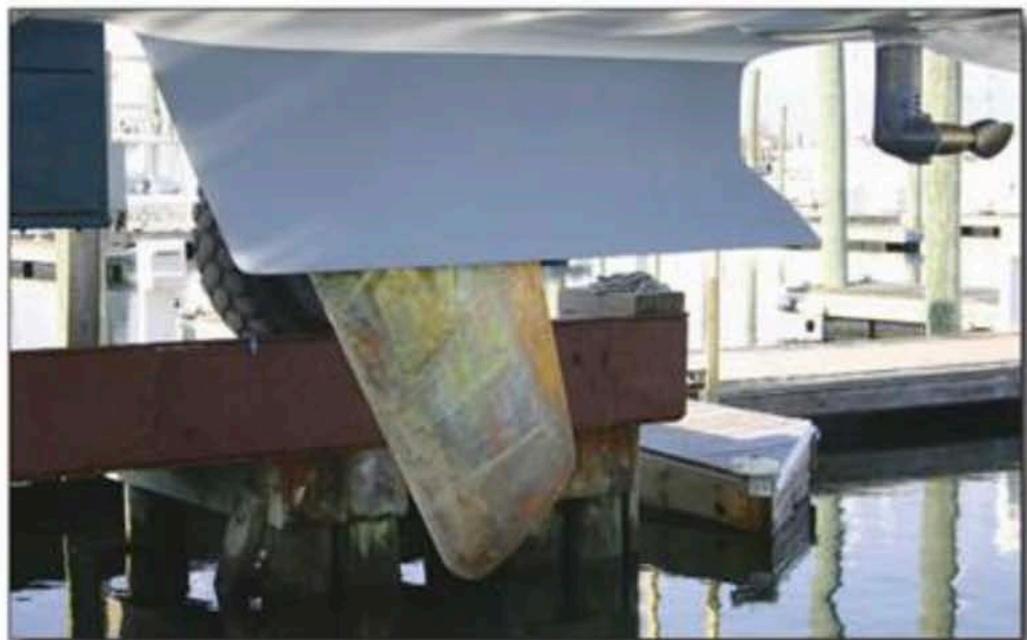
A closer look at the uncoated centerboard and the sail drive on the J/95. The centerboard will be protected with its own sacrificial anode, so the sail drive's anode won't be burdened with the additional load of the centerboard.

When corrosion protection is still needed for an item that is now galvanically isolated, consider local protection for that item. In the example cited above, the builder is installing a sacrificial anode directly to the bronze centerboard for its exclusive protection.

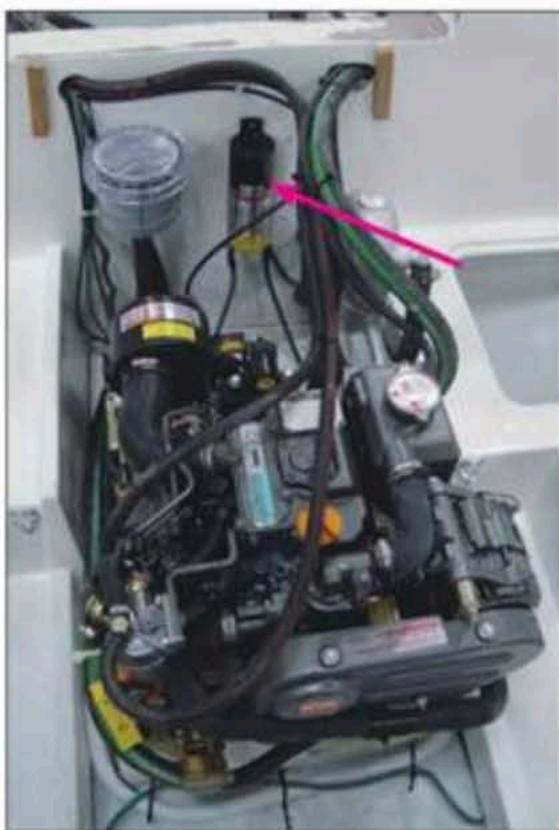
The boat's builder (C&C Fiberglass Components, Bristol, Rhode Island) mounted a standard fail-safe isolator (from Dairyland Electric, Stoughton, Wisconsin) in the engine compartment, where it is easily accessible for necessary periodic testing.
