Mitigating Induced AC and AC Corrosion on a South Texas Pipeline

Case Overview

Two (2) south Texas pipelines shared a corridor with 69kV, 138kV, and 345kV transmission circuits. The pipelines were adversely affected by the various circuits, raising the induced AC touch potentials and AC current densities well beyond acceptable levels during steady-state conditions, as well as unsafe touch and step potentials during fault conditions. ARK Engineering & Technical Services, Inc., located in Braintree, MA, was instrumental in the modeling and design of the AC mitigation system to correct this situation. The identified AC issues were resolved through field analysis, modeling, AC mitigation system design, installation, and subsequent testing.

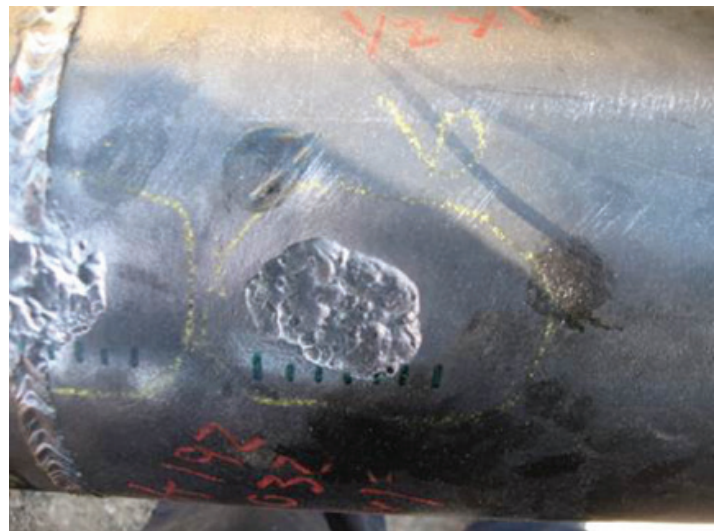
Figure 1: Example of AC corrosion

4. Reduce the AC density through coating holidays (defects in the coating) on the pipeline to less than 20A/m² to prevent AC corrosion effects, per industry practice and the client's goals. Typical industry practices are to limit AC current densities as follows:

- a. With AC current densities less than 20A/m² there is a lower likelihood of AC induced corrosion.
- b. AC corrosion has a moderate likelihood of occurrence for AC current densities between 20 – 100A/m².
- c. AC corrosion has a higher likelihood of occurrence for AC current densities greater than 100A/m².

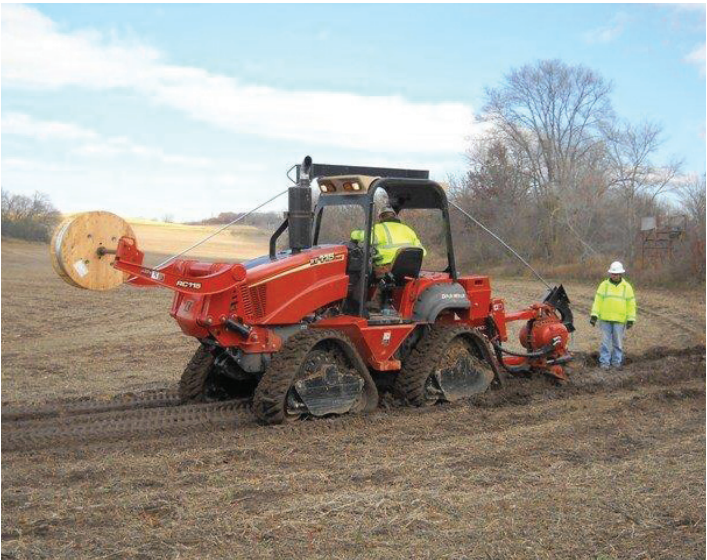
Figure 2: Typical installation of zinc mitigation system

The proposed AC mitigation system design, (installed in 2016), consisted of approximately 68,630 feet of zinc ribbon grounding conductor; installed horizontally, in various segments along the two (2) pipelines.

In addition, a total of 214 zinc ground rods, 10 feet long, spaced at 10 foot intervals, were installed at 13 locations along the pipelines.

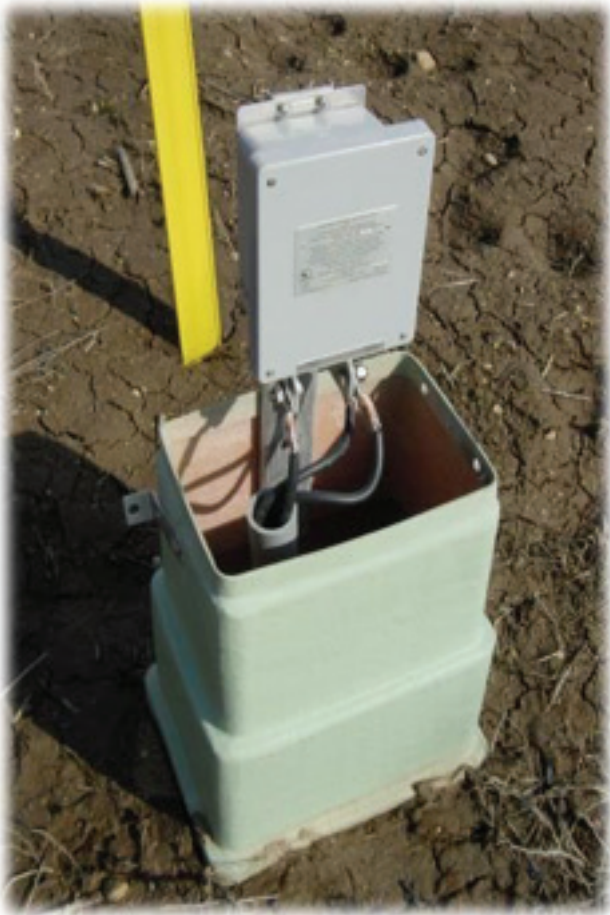
Figure 3: Dairyland PCR in MTP-36 pedestal (with cover removed) on AC mitigation project along high voltage AC right-of-way

Seventy-five (75) Dairyland model PCR-10KA decouplers were connected between the pipeline and the zinc grounding conductor, isolating the zinc grounding system from the pipeline. Pedestals were used to house the PCR units along the pipeline right-of-way.

Solid state decouplers are designed to provide a continuous path for AC current to flow, while blocking the flow of DC current under normal operating conditions. Decouplers provide protection to the public, personnel, and isolation systems while not compromising the cathodic protection system. Dairyland’s solid state decouplers were specifically recommended by ARK Engineering, due to their demonstrated reliability and durability.

Solid state decouplers automatically switch to the conduction mode during AC fault conditions, lightning strikes and device failures. This mode permits AC and DC current to flow. Dairyland decouplers are designed reset to the AC closed/DC open operating mode after each event.

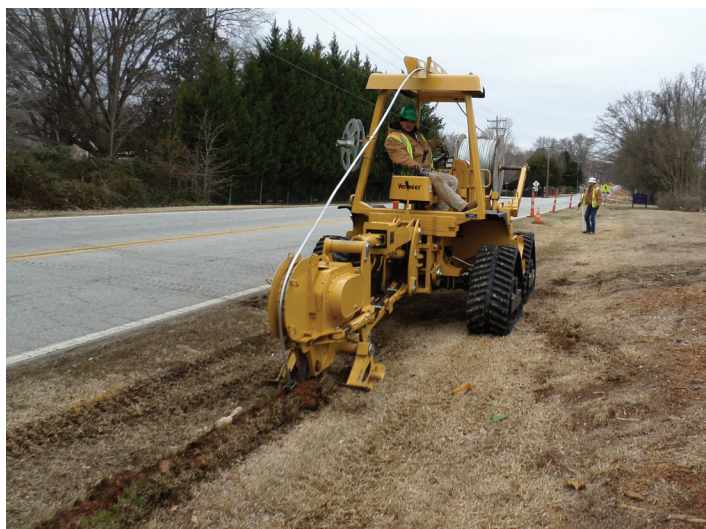
Figure 4: Plowing application of linear zinc mitigation system

Horizontal AC mitigation grounding systems typically consist of linear bare copper cable or zinc ribbon, buried to the side of the pipeline. Grounding must be accomplished without negatively affecting cathodic protection (CP) systems used for corrosion management. This is accomplished by installing and connecting decoupling devices between the AC grounding system and the pipeline/structure. Decoupling devices (or decouplers) block direct current (DC) from CP systems while conducting induced AC to the grounding system, thus reducing the AC interference effects. Decouplers are also rated for various levels of AC fault current and lightning surge current, as these are expected field conditions. Induction modeling and analysis determines the expected fault current values that can affect the pipeline, and can be used to select the decoupler rating.
